Phase I Inspection Report
South Pond Dam
Long Island Basin, Nassau County, N.Y.
Inventory No. 109

5. TYPE OF REPORT & PERIOD COVERED
Phase I Inspection Report
National Dam Safety Program

PHASE I INSPECTION REPORT
NATIONAL DAM SAFETY PROGRAM
SOUTH POND DAM
I.D. NO. N.Y. 109
D.E.C. NO. 192
LONG ISLAND BASIN
NASSAU COUNTY, N.Y.

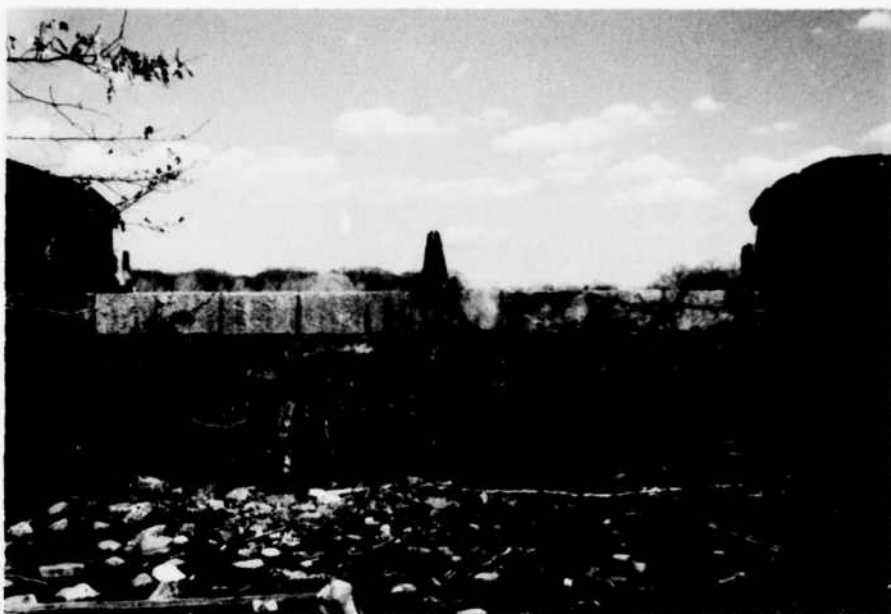
6. VIEW OF SPILLWAY FROM DOWNSTREAM SIDE

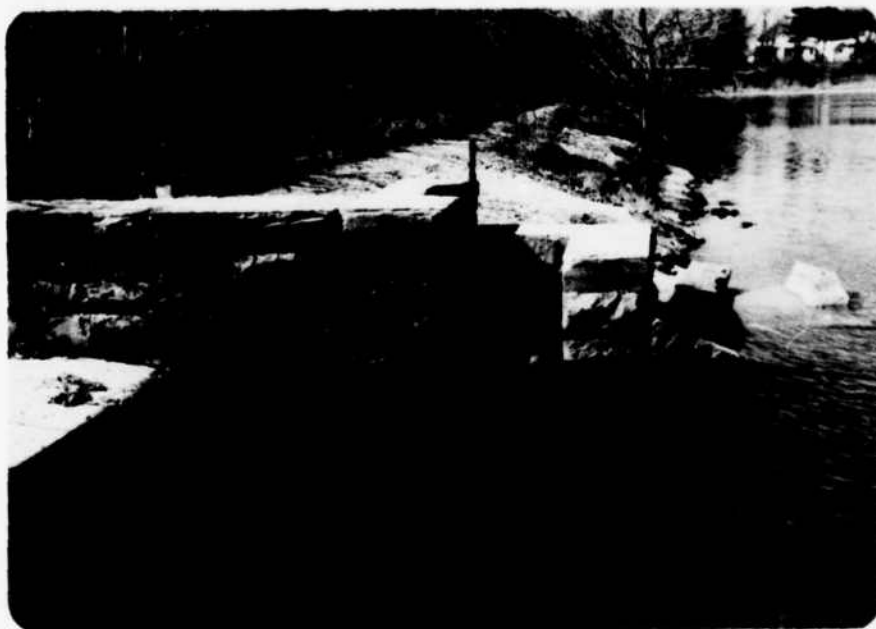
7. VIEW OF APPROACH CHANNEL AND SPILLWAY
TRAINING WALL

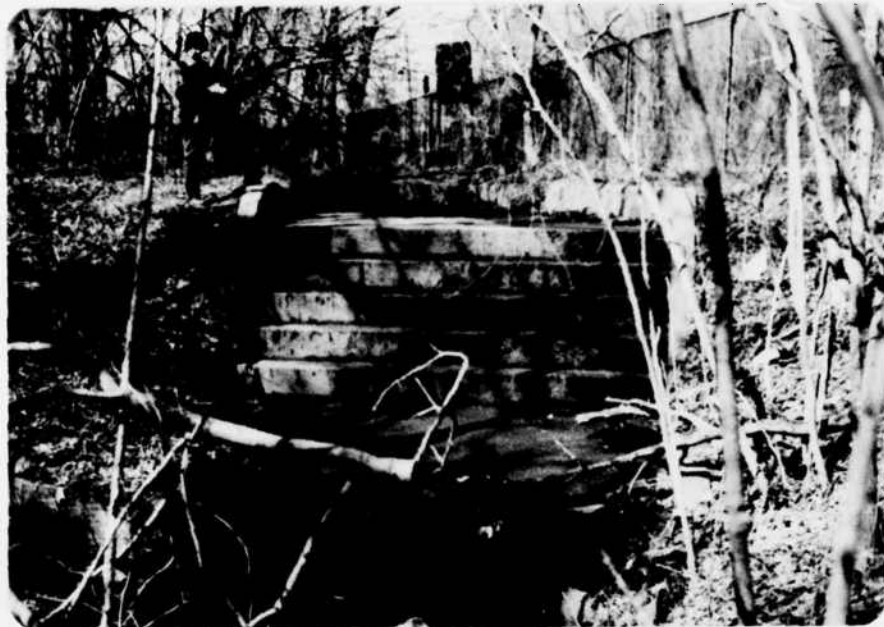
8. VIEW OF AUXILIARY SPILLWAY STRUCTURE

- c. Condition of Auxiliary Spillway Spillway itself is okay except for some undermining at end of step structure. Unable to ascertain intake structure condition and conduit under road, as they are part of Aqueduct system.
- d. Condition of Discharge Conveyance Channel Full of debris, natural and otherwise.

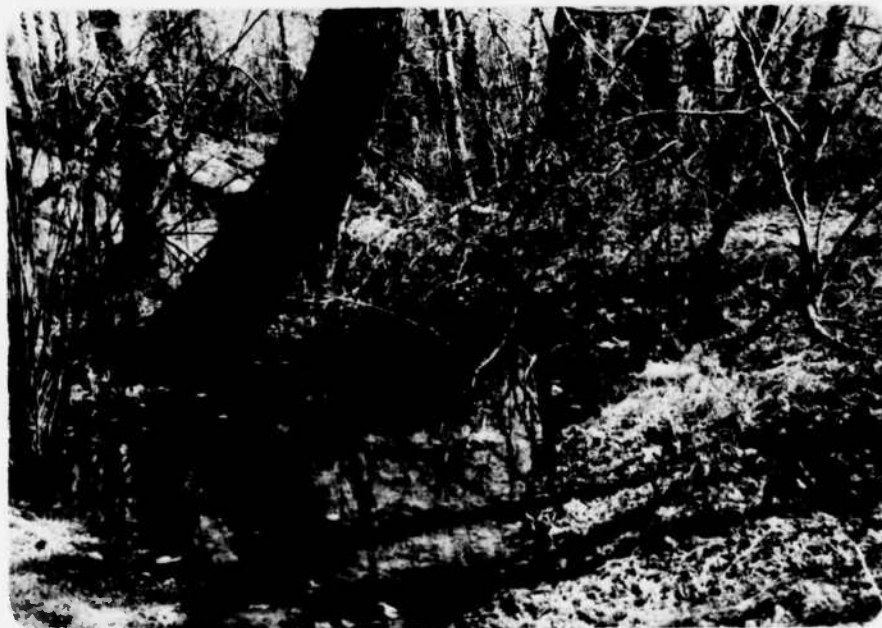
The downstream slope of the dam is somewhat irregular due to the close proximity of the adjacent Lakeview Avenue road embankment. A wet area is located at a low point near the downstream toe about 50 feet to the left of the spillway. It was not possible to determine whether the wet area is caused by seepage or surface runoff which appears to collect at this point from various directions. The flow rate (about 5 gpm) and the clarity of the flow indicates however that it might be seepage flow (see PHOTOGRAPH 9).

9. SEEPAGE PONDING NEAR TOE OF DAM LEFT OF SPILLWAY

1. The seepage near the toe of the dam about 50 feet left of the spillway should be investigated to determine the source and cause. The appropriate methods of correction should be identified and carried out.
